ADDENDUM NO. 01

**Northwestern School Corporation – Maintenance Building
3431 County Rd N 400 W
Kokomo, IN 46901**

**RE: PRERENOVAION ASBESTOS INSPECTION
NORTHWESTERN ATHLETIC STORAGE BUILDING
3431 NORTH COUNTY ROAD 400
KOKOMO, INDIANA 46901
ALLIANCE ENVIRONMENTAL GROUP PROJECT NUMBER NNT02A05**

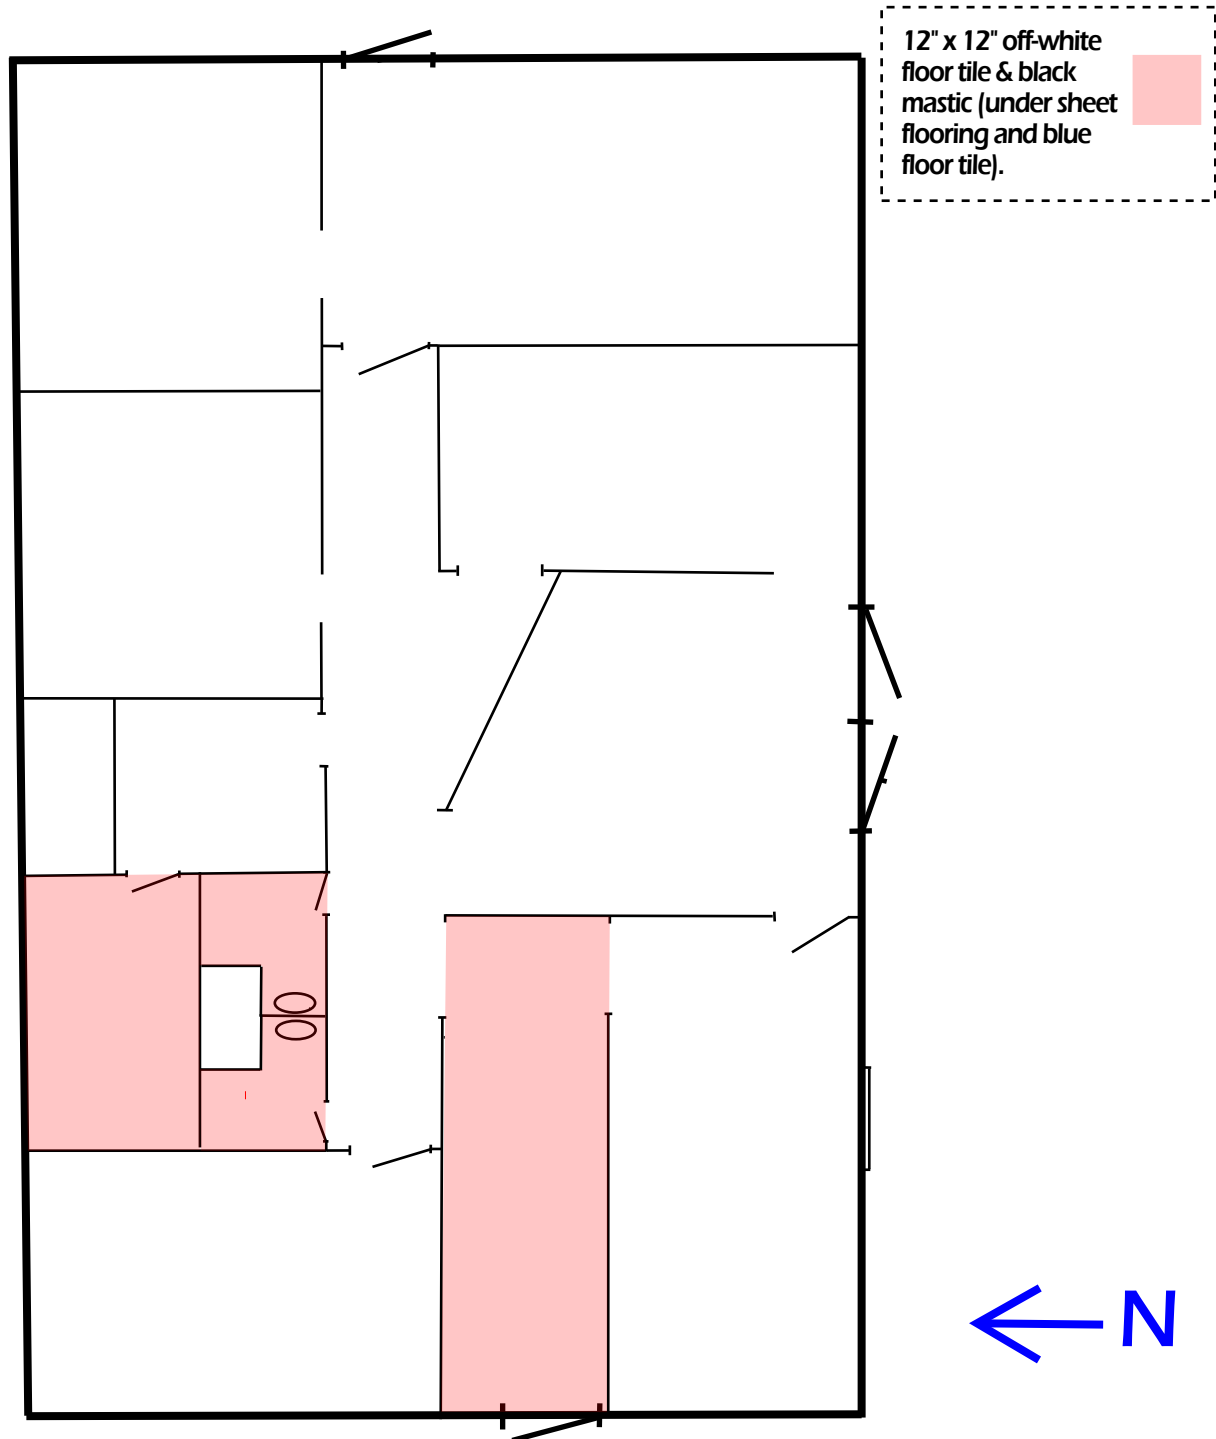
NORTHWESTERN ATHLETIC STORAGE BUILDING: (Not to Scale)

- 12" x 12" Off-white Floor Tile (under 12" x 12" blue floor tile)
- Black Mastic Associated with 12" x 12" Off-white Floor Tile
- Asphaltic Roofing Materials (Assumed)

Due to the scope of work and the current state of the building, attempts were made to identify and quantify all asbestos-containing materials within the scope of work, however, some asbestos-containing materials may be present in inaccessible areas or cavities in walls, chases, and above hard ceilings. If any suspect asbestos-containing materials are discovered during demolition activities, work should cease until the material can be sampled by a licensed asbestos inspector or assumed to be asbestos and removed by a licensed asbestos abatement company.

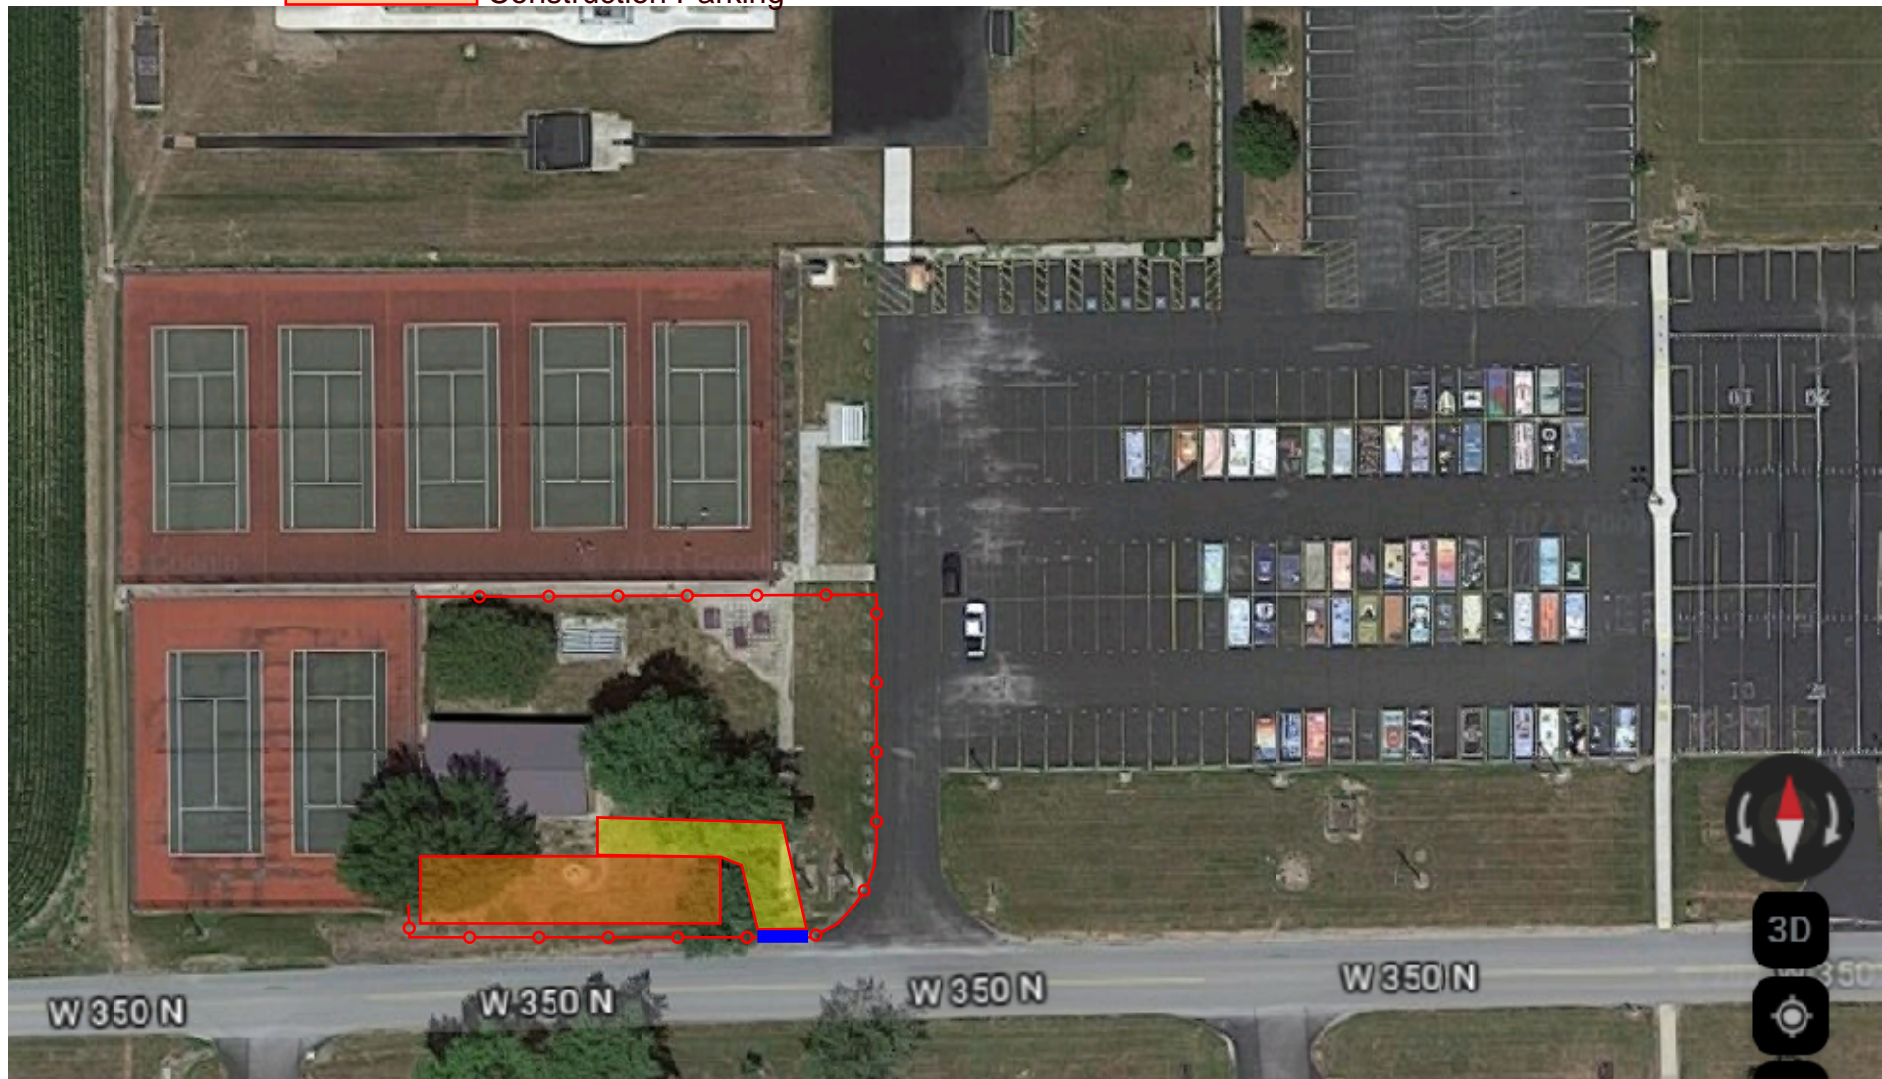
Northwestern School Corporation
Maintenance Building
Site Logistics Plan
11/15/23

- Construction Fence
- Construction Entrance
- Construction Haul Road
- Construction Parking

1. Provide construction fence and gate, construction entrance, haul road and construction parking as indicated on Site Logistics Plan dated November 17, 2023. Maintain haul road(s) and construction parking area during construction; remove haul road(s) and construction parking area when practical and then restore disturbed existing conditions which are indicated to remain.
